International Space Station Solar Array Guide Wire Micrometeoroid and Orbital Debris Damage

Daniel Kent Ross, Johnson Space Center

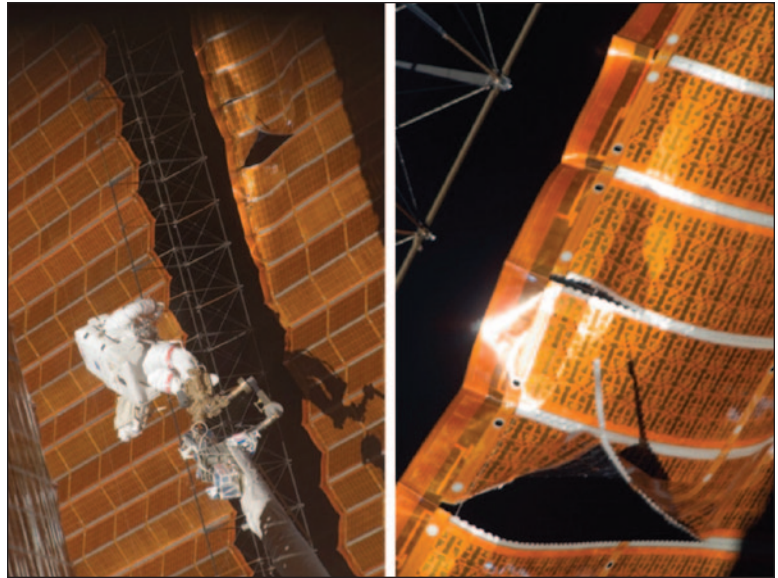
Fig. 1. Tears in the International Space Station Port 6 solar array wing 4B after attempt at redeployment during the STS-120 mission.

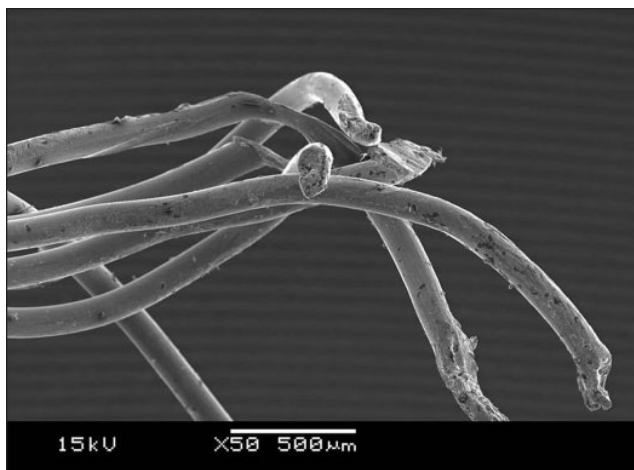
Fig. 2. Frayed end of 4B solar array wing guide wire. Wires at bottom and in lower right-hand corner exhibited melt near ends.

Directorate. Seven individual wires had been broken at the frayed end (figures 2 and 3). The microscopes' examination revealed that, on three of those wires, a large amount of material appeared to have been melted at one time near the broken ends (figures 4 through 6).

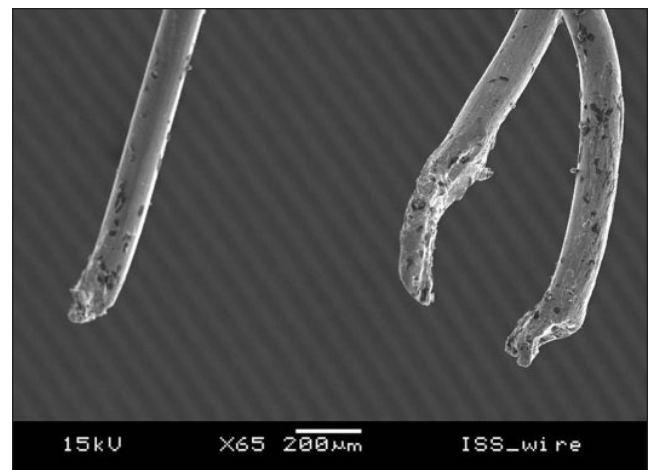
Fig. 3. Three wires exhibiting melt.

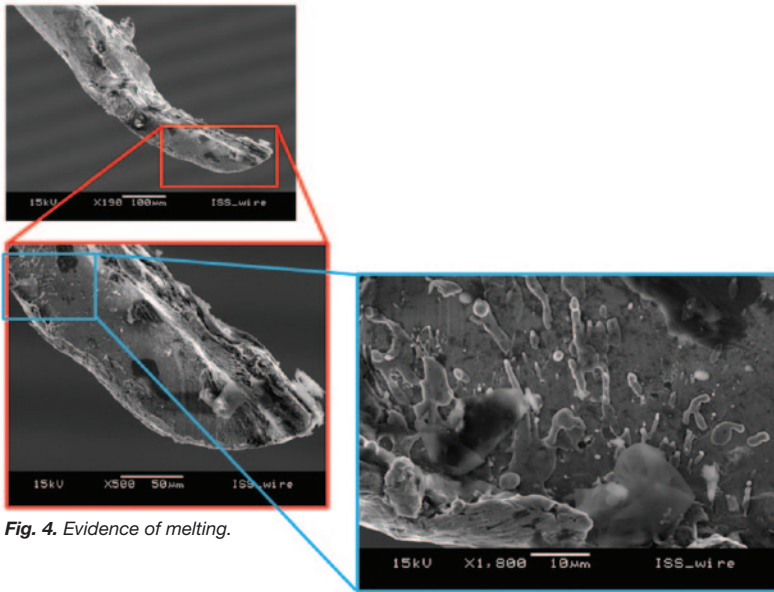
Fig. 4. Evidence of melting.

melting and plastic flow local to the impact site. The presence of melt is a clear indication that the damage to these three wires was caused by MMOD impact. Other wires in the bundle appear to have been broken by mechanical action. A likely scenario that explains the observed damage to the guide wire is that MMOD impact damaged and broke a few of the wires, which allowed the guide wire to snag in a SAW grommet during deployment. Subsequently, as the process of deployment continued with a snagged guide wire, additional wires in the guide wire were sheared as they were pulled against the grommet.

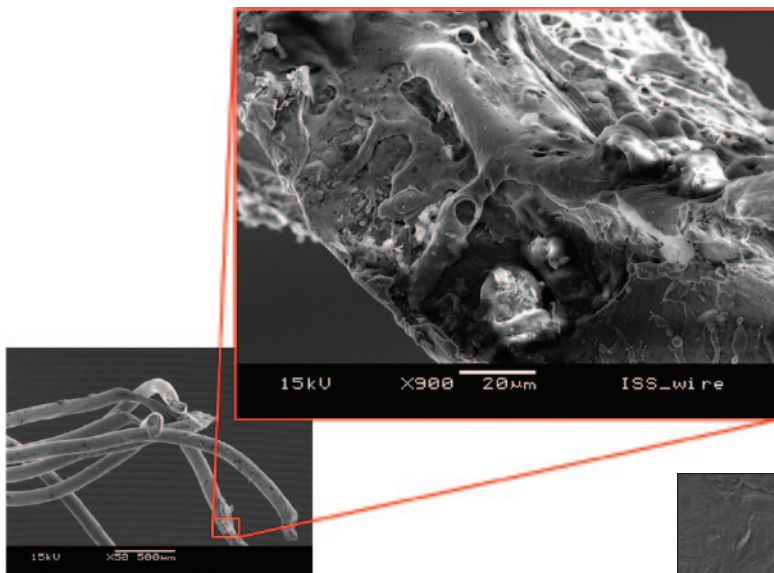
Fig. 5. Additional evidence of melting.

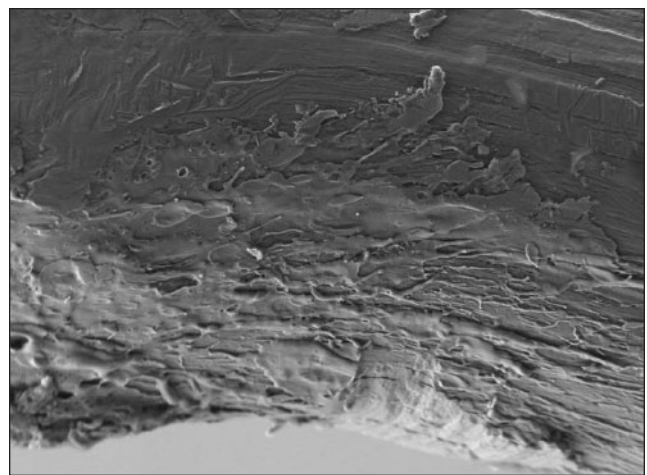
Fig. 6. More evidence of melting.

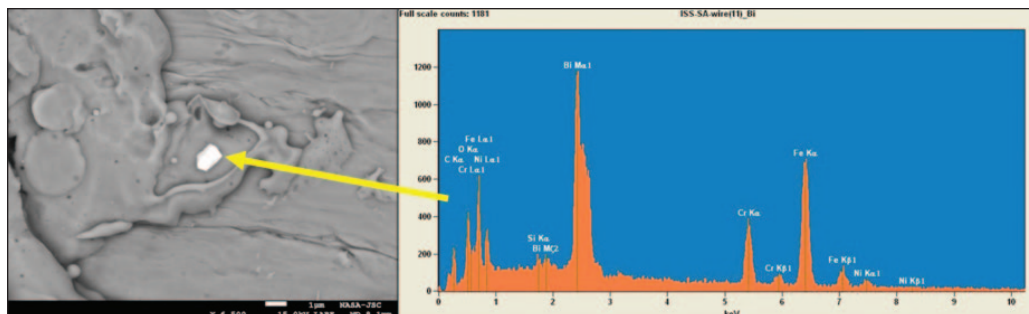
of the wires that had considerable melt. The composition of these particles suggest the possibility that an orbital debris impact was responsible for breaking wires within the guide wire bundle. Bismuth metal, gold-copper-sulfur, gold-silver-copper, lanthanum-cerium, antimony-sulfur, and tungsten-sulfur bearing particles were identified (figures 7 through 9). No evidence of micrometeoroid impact was identified. The wire is composed of iron-chromium-nickel (FeCrNi)-rich stainless steel, and these elements are present in all spectra. Also, carbon-rich particles are abundant on all of the wires, likely from the plastic bag containing the sample (i.e., contamination).

Fig. 7. Bismuth-rich particle on melted zone on steel wire. Iron, chromium, and nickel peaks are from underlying wire.

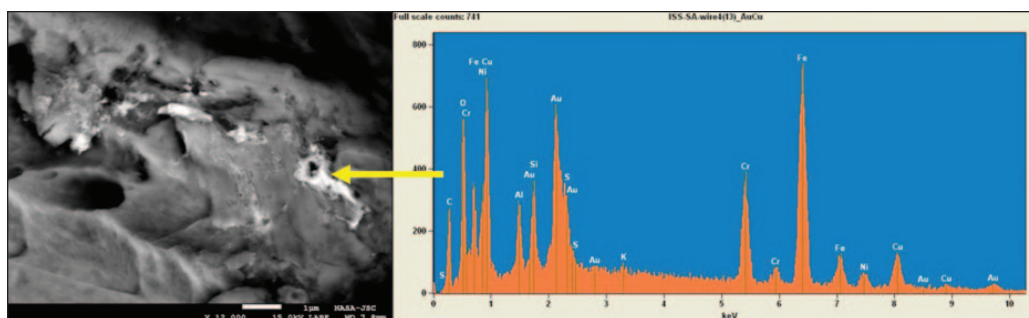
Fig. 8. Gold-rich particles.

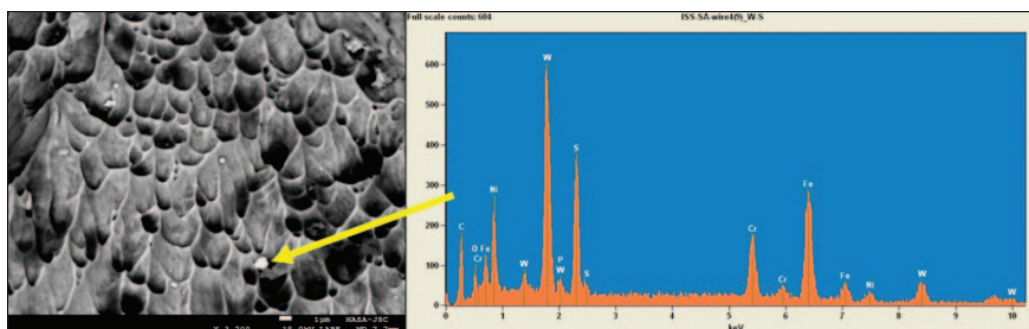
Fig. 9. Tungsten-sulfur particle on damaged steel wire.
